# Causes of Heavy Vehicle Fires

# By Peter Hart Hartwood Consulting Pty Ltd

# Heavy Vehicle Fires – Causes and prevention

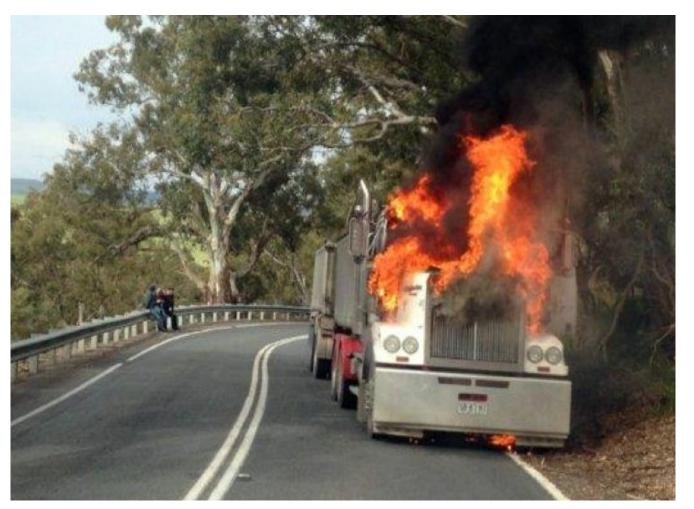
Engine compartment fire – Adelaide Hills

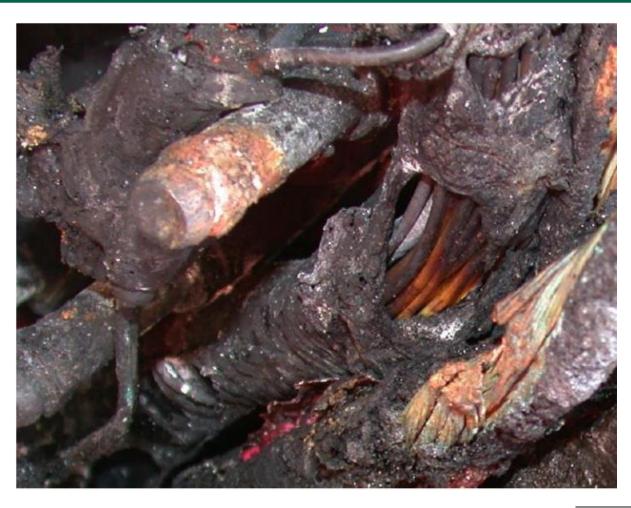
Fire was caused by the alternator cable running over the engine stud.

The split conduit opened up and let the stud in to rub on the cable.

Sparking ignited the polymer conduit.

This cable had no circuit breaker protection.

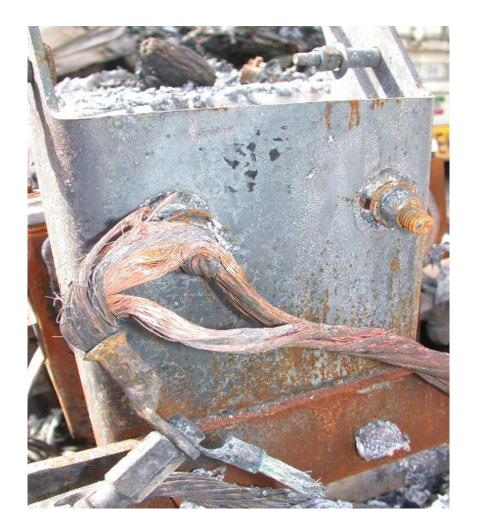
Rasping of the conduit and plastic led to a short-circuit.

This fire occurred inside the battery box.

The sparking ignited the polymer conduit.

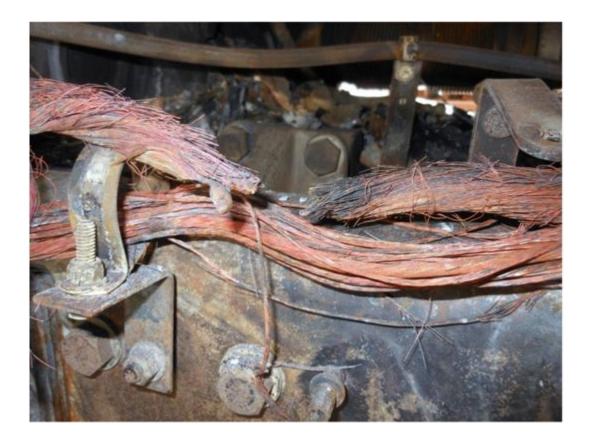
A rub on the positive battery cable at a steel-spined clamp point underneath the cabin.

Sparking on main cable ignited the split-plastic conduit.

This cable had no electrical fuse protection.

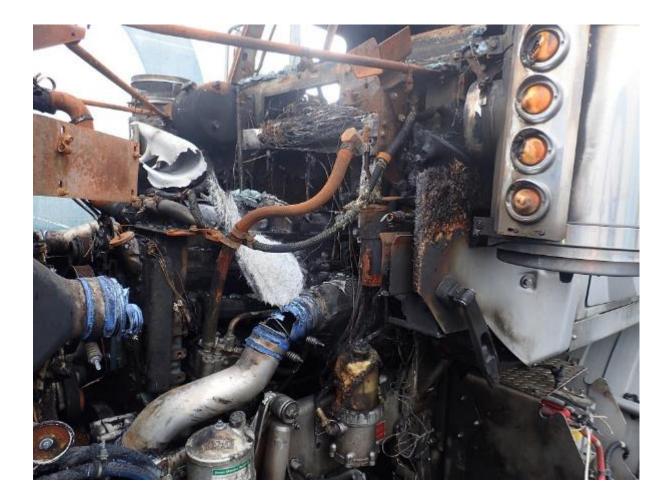
The fire appears to have started in the electrical compartment on the firewall underneath the windscreen.

This is not so!

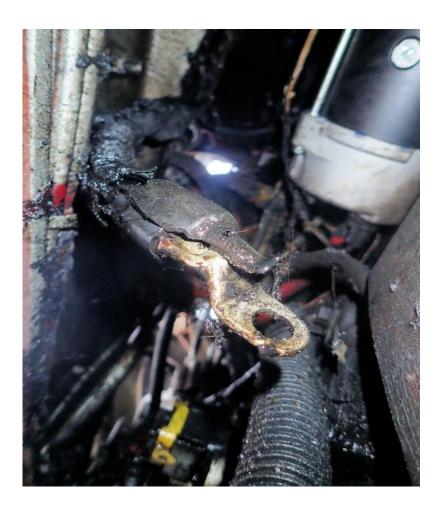
The fire started at a minor link cable between the starter motor and the chassis rails.

Because the main return cable had been left off the starter motor when it was changed, starter motor current returned via a minor cable, which overheated.

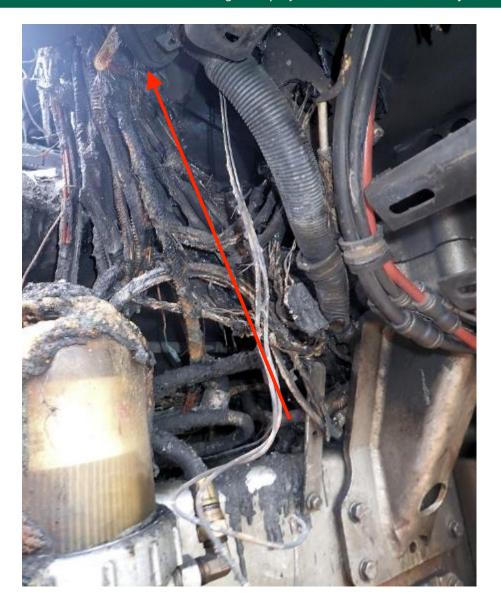
The fire spread from the starter motor region to the cabin electrical installation on the firewall just below the windscreen.

The fire spread via burning conduits.

The plastic conduits provided fuel for the fire and then spread it vertically.

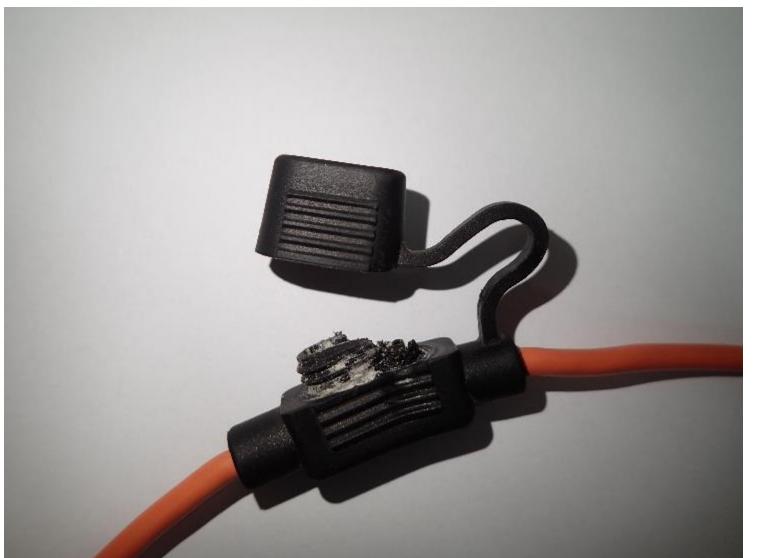
Carbonate filler comes out of the rubber when it gets hot.

This contaminates the fuse terminals and may result in hot terminals.

Terminal heating = I.I.R

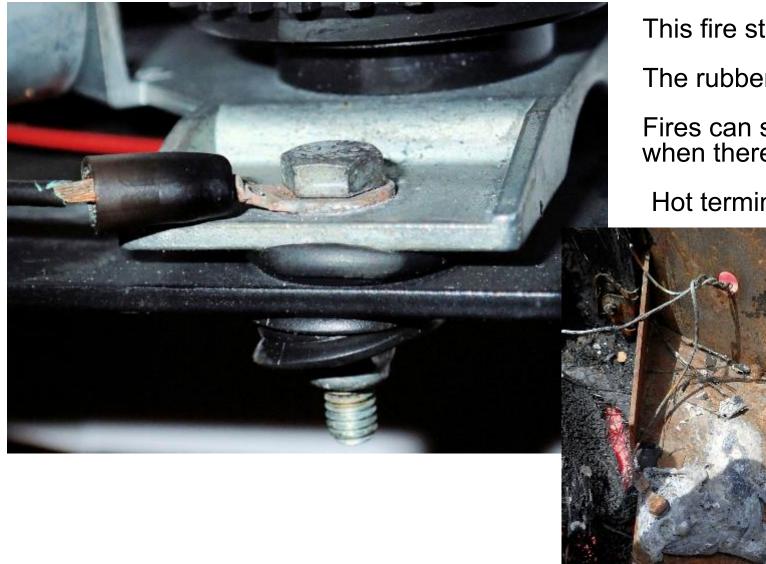
This fire started in a beacon light on a cabin roof.

The rubber pad is used for vibration isolation.

Fires can start at return electrical connections when there is poor clamping force.

Hot terminals result. Plastics catch fire.

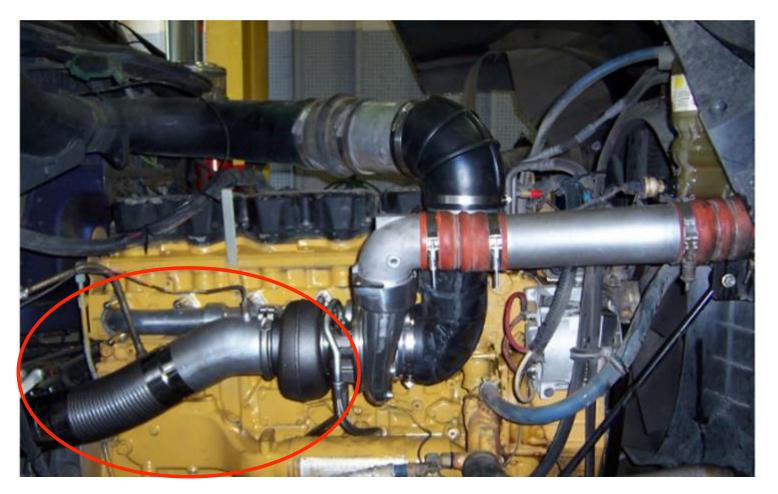
Only the exhaust and turbocharger are hot enough to ignite oil or diesel fuel.

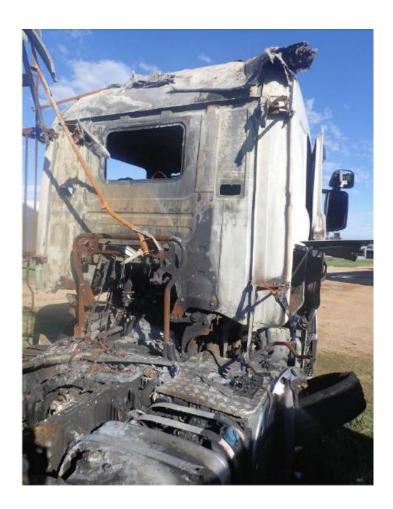
The fire started outside the cabin on the RHS just in front of axle 2

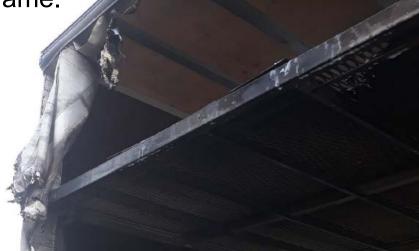
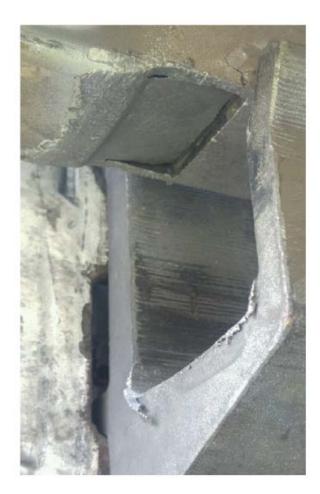
Fire is caused by hot metal rubbings from the support brackets accumulating on top of vulnerable freight boxes.

Polyamide or polyurethane U-shaped pads are being trialled to prevent metal-metal rubbing.

Sideways movement is needed to avoid stress points in the metal frame.

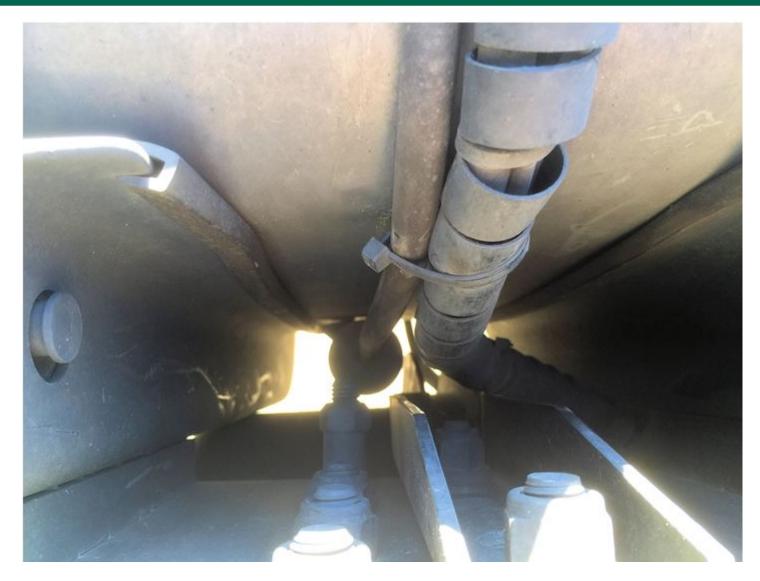
The fuel lines run down the side of the fuel tank.

They are polyamide hoses with poor mechanical protection (spiral wrap).

A leak from the polyamide return line (smaller line) will cause a fuel spray without any change in engine operation.

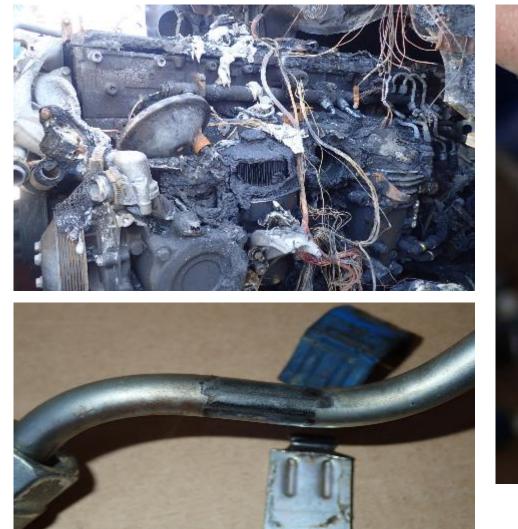
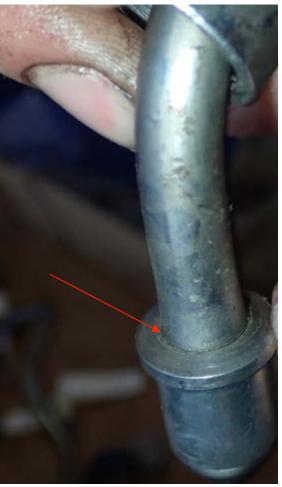
High pressure engine tube cracks.

The cracking and wearing of tubes is the result of vibration due to pressure pulses in the high pressure fuel injection system.

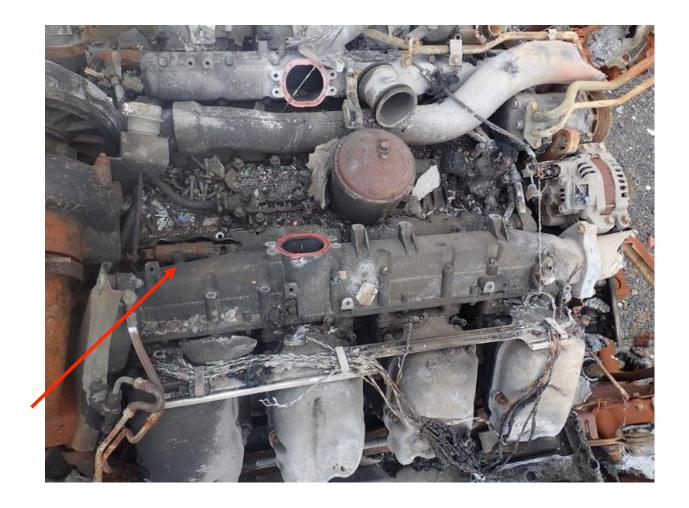
The engine tappet shaft cover broke because of an internal engine failure.

Engine oil sprayed onto the turbocharger, which is located at the rear of the engine, and started the fire.

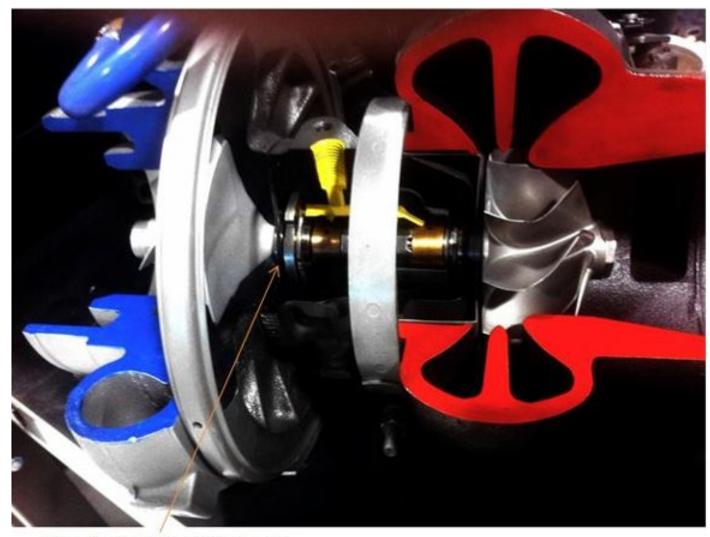
Turbocharger fires are caused by turbocharger oil seal failure.

The oil seals fail and fire starts on the exhaust side. The fire then spreads to the blowerside via failed oil seals and escapes via the aluminium or rubber air intake pipes.

Risk factors are: hot exhausts and poor oil seal design.

The oil seal on the air-intake side

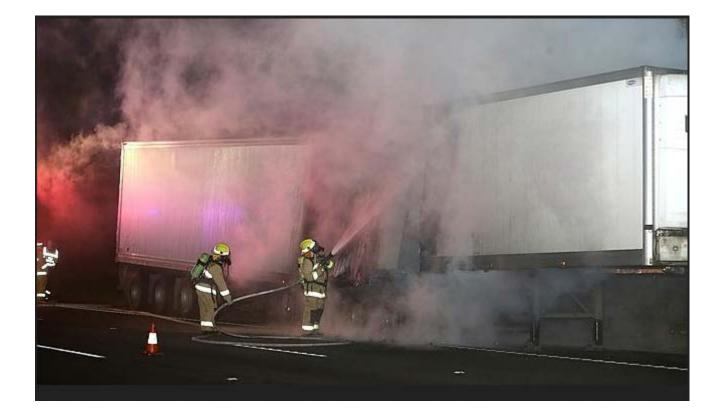
This fire closed one side of the M2 in Sydney during the morning peak hour.

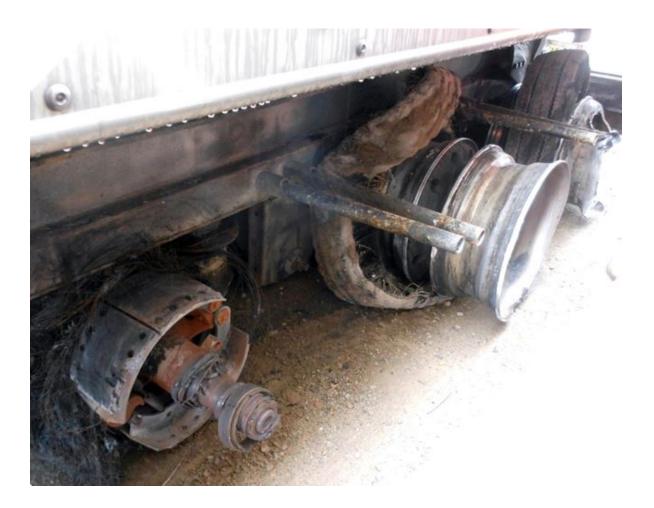
Mechanical failure of the bearings on the front axle is evident.

Note the white edges and crumbling on the brake linings, which witness extreme brake temperature due to dragging brakes because the drum was not centred

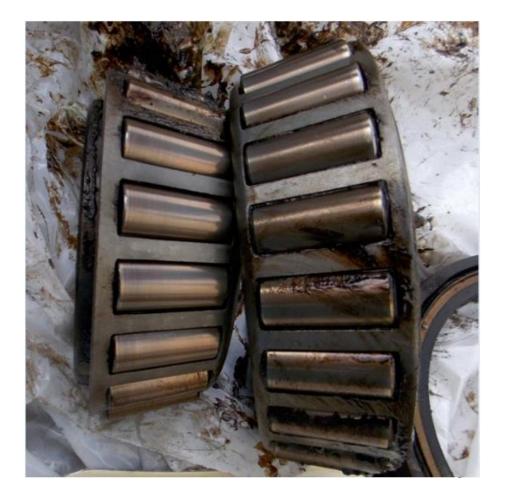
Distressed lubrication on new bearings from axle 2.

Excessive pre-load adjustment caused the early bearing failure.

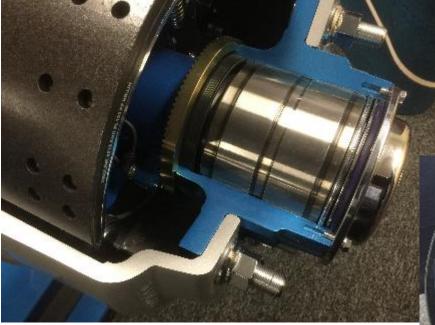
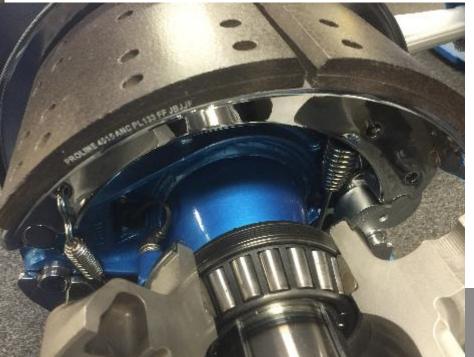
Bearings wear out, whether they are unitised or open.

Good practice is to have a replacement policy that reflects the nature of the operation. Bearing manufacturers do not estimate bearing life because of variable operating conditions.

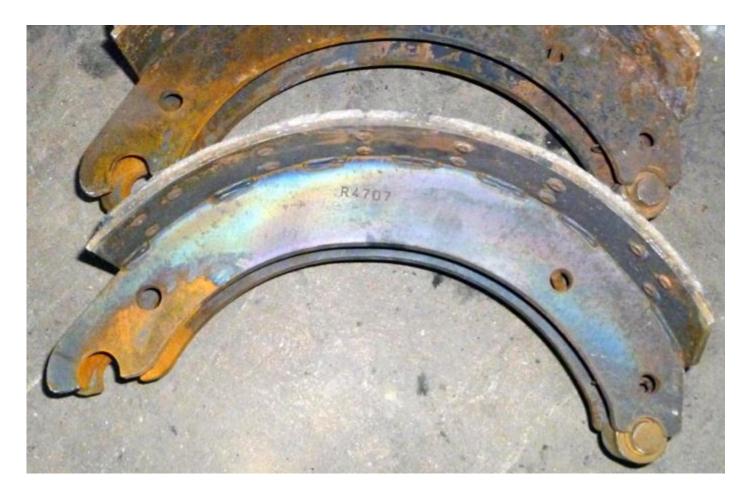
Dragging brakes cause extreme brake drum temperature.

Drum heat then spreads to the tyre rim via the aluminium wheel rims.

Dragging brakes are caused by bearing failure or brake system defects.

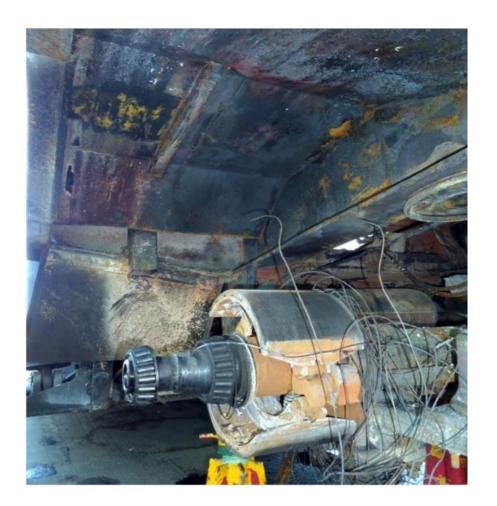
The air suspension deflated en-route and the tyres rubbed on the steel mudguard.

The tyres caught fire at the outside.

This was a car-carrying trailer. The mudguards are sturdy to prevent stones being thrown up and reaching the cars.

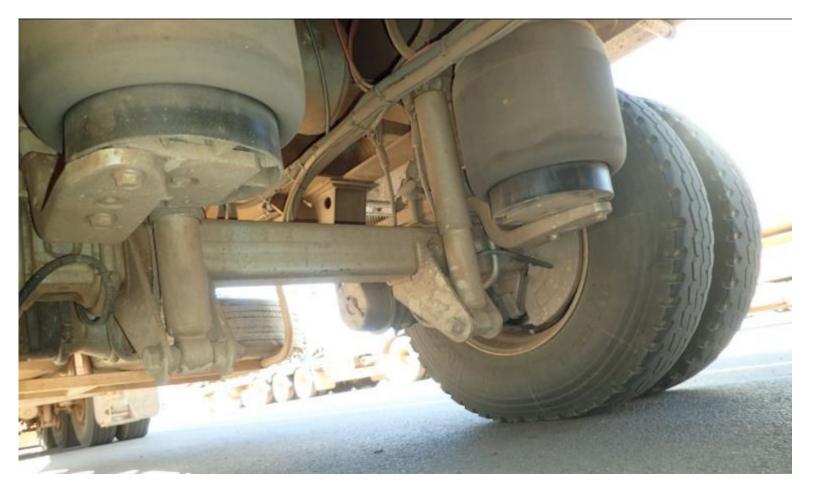
Air suspensions will deflate if a supply tube fails.

The driver will see it on the truck but may not see it on a trailer.

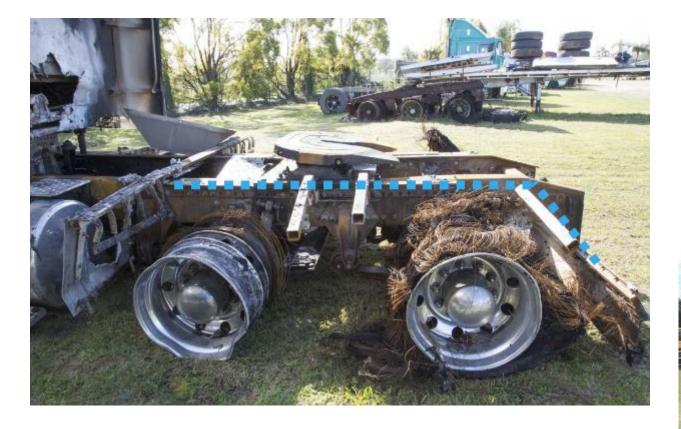
Bracket failures on heavy-duty mudguards.

Rubs on plastic mudguards do not cause fires as the plastic brakes away.
