# Causes of Heavy Vehicle Fires

# By Peter Hart Hartwood Consulting Pty Ltd

# Heavy Vehicle Fires – Causes and prevention

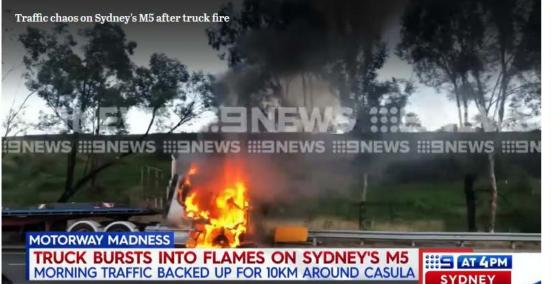
Emergency services were initially called about 7am following reports of a prime mover well alight on the M5 near the intersection with the Hume Highway in Casula.
